# SHORE EROSION STUDY Technical Report

# Appendix

SHORELINE EROSION AND BLUFF STABILITY ALONG LAKE MICHIGAN AND LAKE SUPERIOR SHORELINES OF WISCONSIN

> DOUGLAS AND WESTERN BAYFIELD COUNTIES WISCONSIN POINT TO BARK BAY

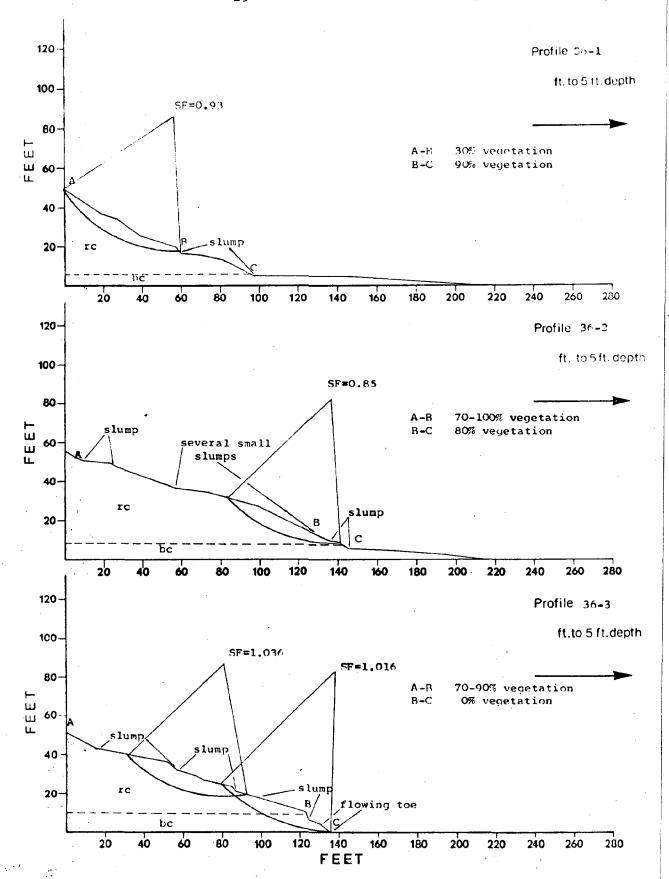
#### Sec. 36, T 49 N, R 13 W

- a) red clay; slumped; protected by beach
- b) clay, slumped, protected, vegetated with alder and grass or scarped at large slump blocks
- c) clays, slumped, partially protected, failing for 10 ft vertically by shallow sliding with 2-3 ft scarps at base unvegetated
- 'd) clays, slumped, unprotected from waves, failing by shallow sliding and mudflows with 8-12 ft scarps at base, unvegetated
- e) clays, slumped, partially protected, failing for 10 ft vertically by shallow sliding with 2-3 ft scarps at base unvegetated

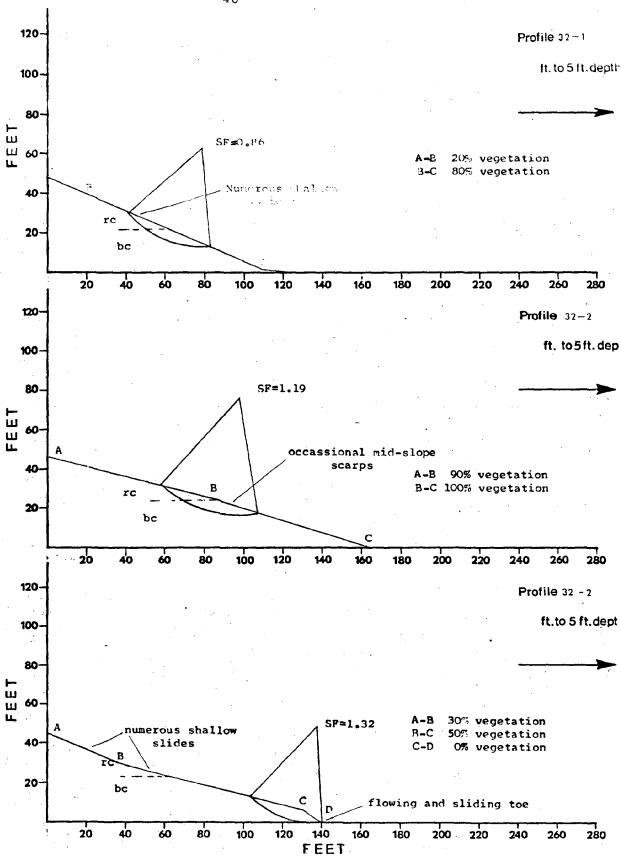
T.49 N., R.12 W., Sec. 32

- a) 45-50 ft high; crest scalloped; shallow slides; vegetation (50-60%) restricted to clump on actively moving slump blocks; clay
- b) 45-50 ft high; crest subdued; well-vegetated (80-90%) with alder, birch, some conifer, grass, moss, and horsetails toward the toe; fairly stable of late but fresher a-mid-slope scarp was often noted, clay
- c) 45-50 ft high, crest newly scalloped; vegetation being destroyed (0-10%); shallow slides, clay

- a) mixed-colored clay (red-brown-gray); slumped; generally protected from wave action
- b) red and brown clay; slumped; under wave attack; failing for12 ft vertically by shallow slides and mudflows

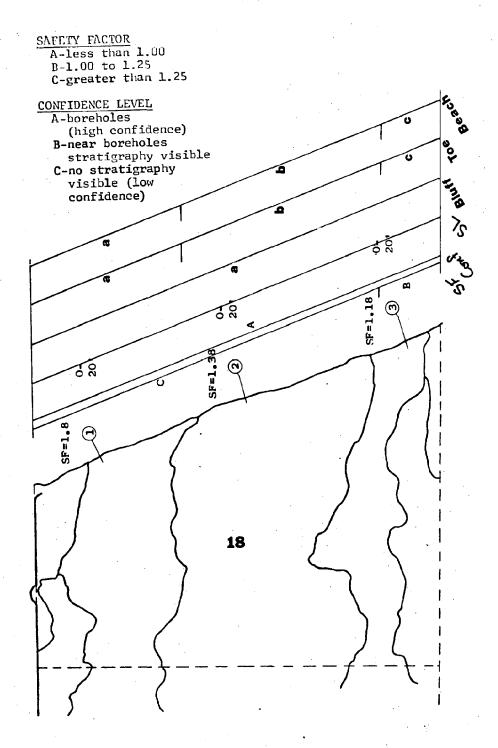
#### SEC 18 T49N R10W

a) 50 ft at west, dropping to 35 in middle and rising back to 40 ft at east; crest broadly scalloped, both scarped and rounded; failure is by many processes and is quite varied spatially: large rotational slumps, slides and flows on slump scarp; brown silty clay; birch, alder, grass, moss and horsetails.

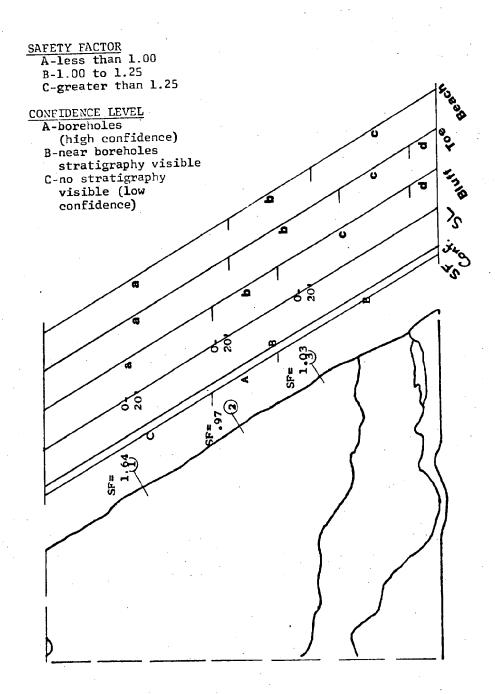
#### SEC 9 T49 N R10 W

- a)30 ft; coarse sand with some pebbles at water; .5 ft. wave-cut face close to toe; boulders offshore
- b)discontinuous, interrupted frequently, 10-15 ft. coarse sand with boulders offshore
- c)20-80 ft; broadest just west of stream and across estuary coarse sand with pebbles near water; 2-3 ft wave-cut face often present.

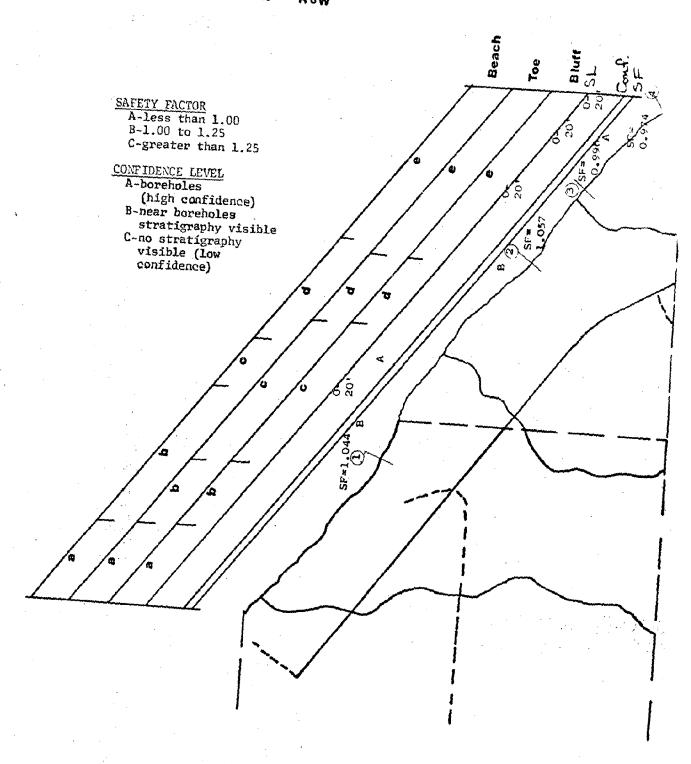
SEC 22/15 T50N R8W

- a) 15 ft sandy, pebbles at shore
- b) 10 ft cobbles with sand at shore and more cobbles immediately of shore
- c) 20'; sandy, pebbles at shore
- d) 20'; even width; cobbles
- e) 5'; cobbles with numerous: slumped trees

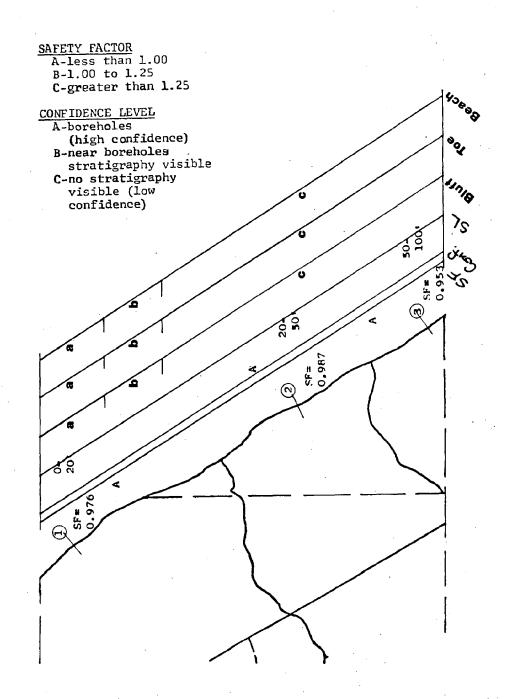
# SEC 14/11T50 N R 8 W

- a) 5-10'; cobbles with sand; occasional covered by sand fan; numerous slumped trees
- b) 20-25; sand with cobbles; sand spits at creek
- c) 10-15 ft; sand and cobbles; sand at creeks

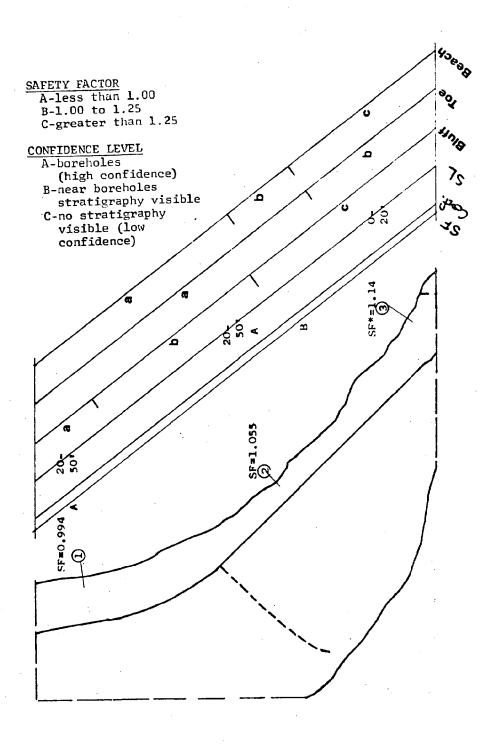
### SEC 26 T 51 N R 7 W

- a) 15-25 ft; coarse sand, with pebbles at water and cobbles at toe occasionally
- b) 15 ft cobbles and boulders with coarse sand at water occasionally
- c) 0-2 ft; cobbles and coarse sand; mostly absent

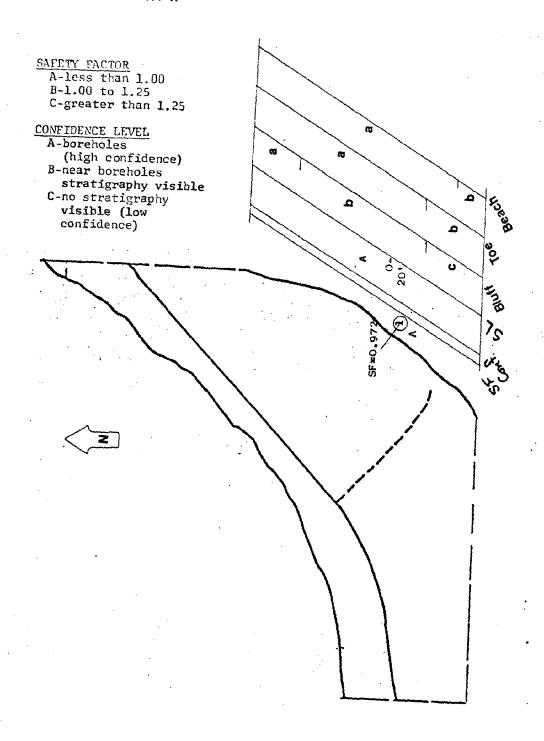
# SEC 26 T51N R7 W

- a) 10-15 ft; cobbles with boulder and occasional coarse sand matrix
- b) 0-5 ft; cobbles; interrupted by blocks from failures
